DHOBIKHOLA OUTLOOK: REVIVING THE DEAD RIVER

**DAAYITWA
NEPAL PUBLIC SERVICE FELLOWSHIP
SUMMER 2014**

ABSTRACT

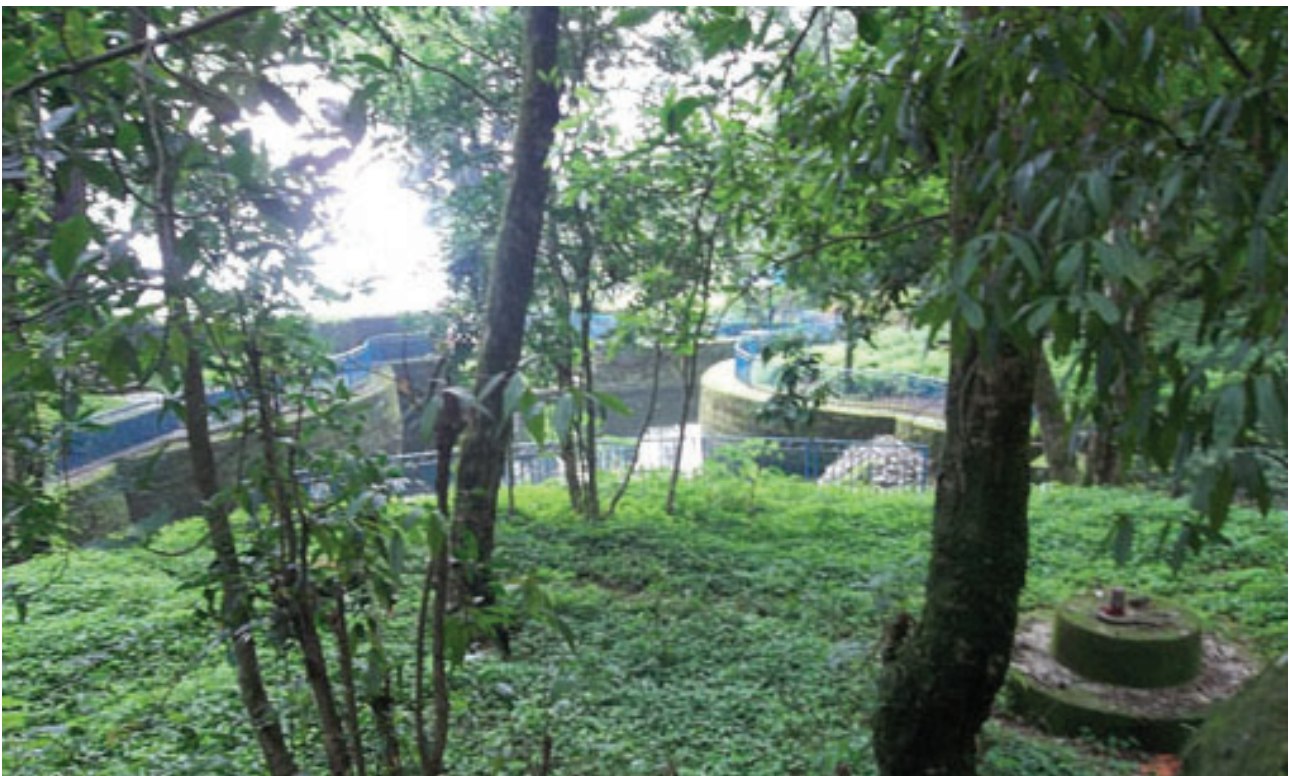
Figure 5: Muhan Pokhari, Shivapuri National Park

Tapping of water from main source of river like Dhobidhunga and Muhanpokhari for drinking and domestic purpose is the root cause of decreasing water discharge. Decrease in discharge exerts enormous impact in the overall river ecosystem by damaging the habitat for aquatic life, exposing the river banks and channeling the flow. There doesn't exist any guideline or policy related to river water diversion and extraction. According to KMTNC (2004), about 30 million litres of water is tapped everyday from rivers such as Bagmati, Bishnumati and other small streams originating from the Shivapuri hills. Water from rivers such as Manahara, Nakkhu and Balkhu has been intensively utilised for agriculture, industries, tourism and recreational activities.

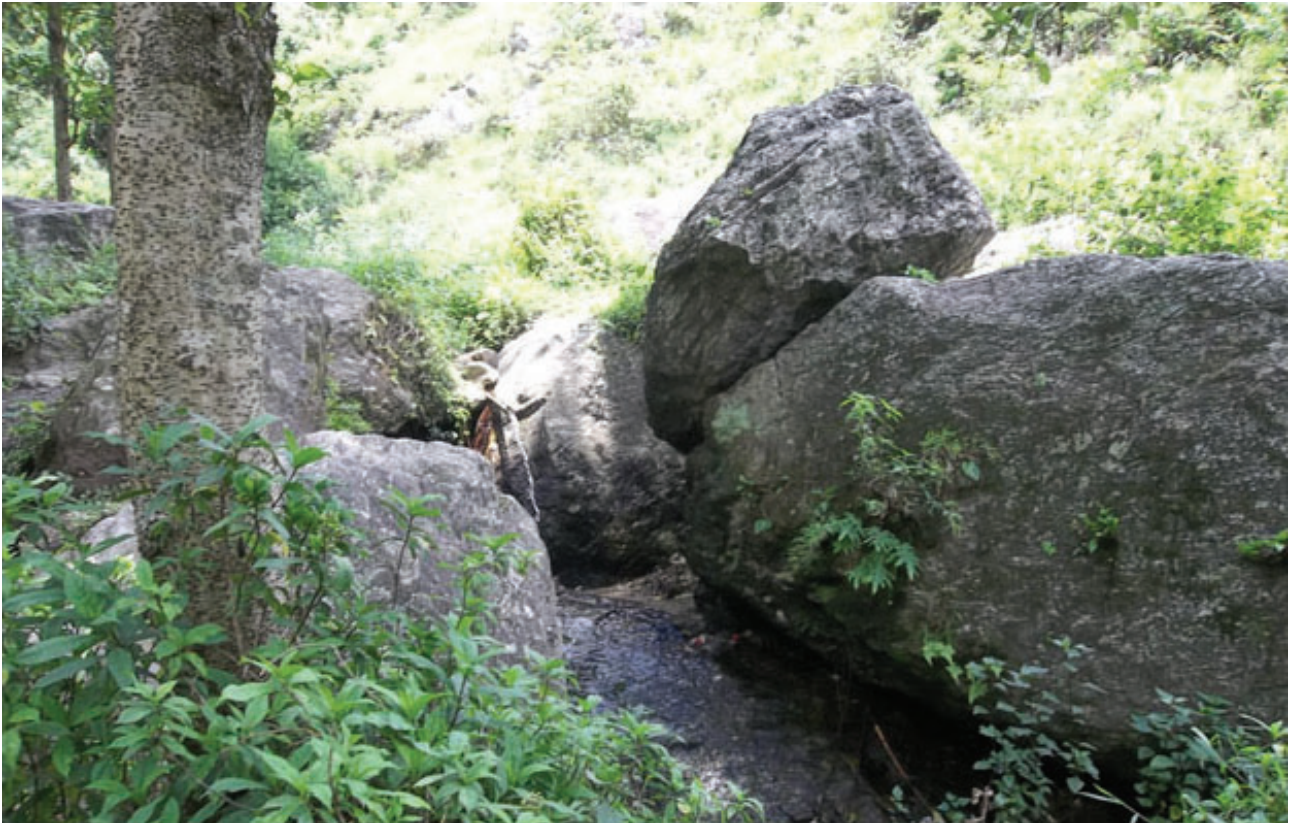
Figure 6: Dhobidhunga, Source of Dhobikhola

This is the starting portion of Dhobikhola. It lies on the foothills of Shivapuri. The quality of water at Dhobidhunga is quite good, this water can even be directly used for drinking purpose. At Dhobidhunga the channeling of water is done and it is stored in a tank for water distribution to community nearby. As we go further downstream we can see water being diverted to fields for irrigation. Biodiversity is ample in this portion of river.

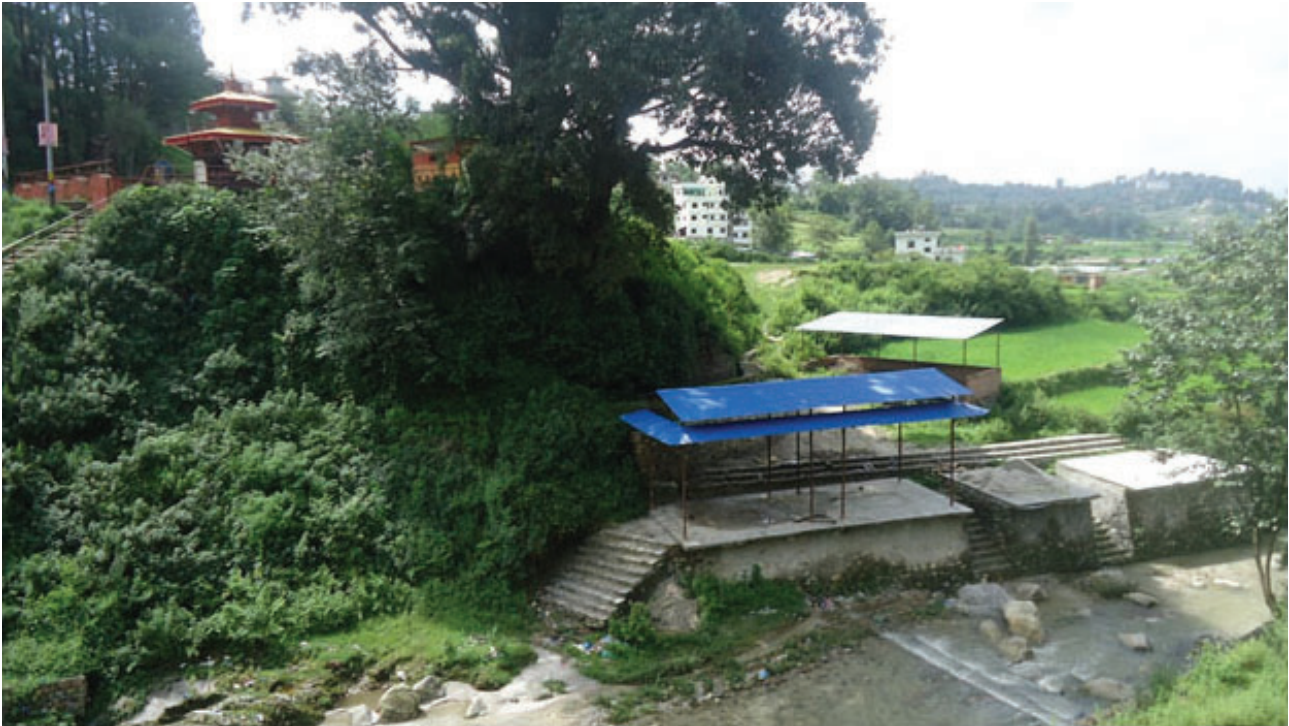
Figure 9: Bhadrakali temple and Ghat

As Dhobikhola passes through a gorge, we can see a temple there, Khadka Bhadrakali. There is also a Ghat. Cremation of dead bodies is done there and thrown into the river. Some amount of pollution in river happens here due to cultural practices of locals. We can also observe channeling of water from the river for distribution purpose. Moving further downstream, we can see squatter settlement. Water is polluted due to direct mixing of domestic wastes in this region. They have also reared pigs and ducks and their byproduct is further polluting the river.

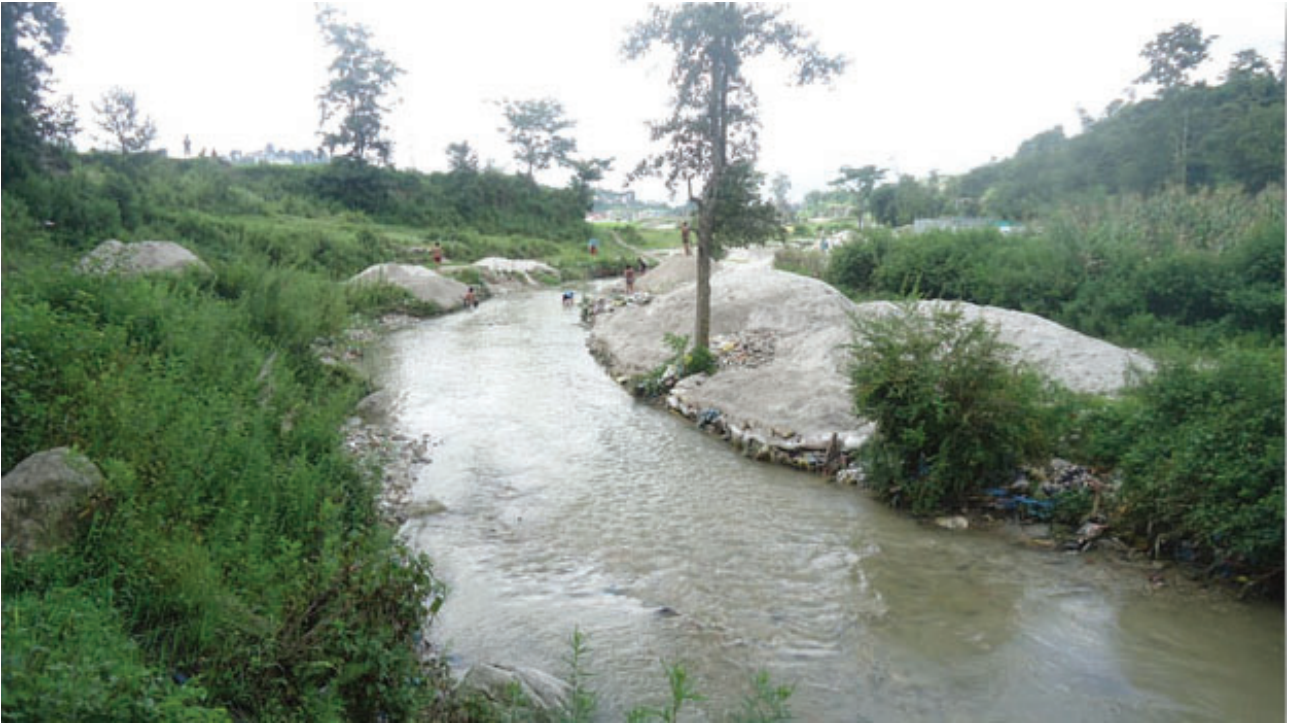
Figure 10: Sand mining at Chunikhel

At Chunikhel, sand mining is excessively done, we can see people working in river and also lumps of sand on riverbank. Excessive mining is disastrous as it can affect the flow of river and thus ultimately affect the infrastructure lying nearby on downstream section. We can also see settlement growing slowly, as river course into the city. Before it enters Kapan we can see rice field when we walk along the bank. A paper industry can also be seen. Now we can also see big sewerage pipes opening into the river. Water quality here is not good, amount of biodiversity also slowly start to diminish.

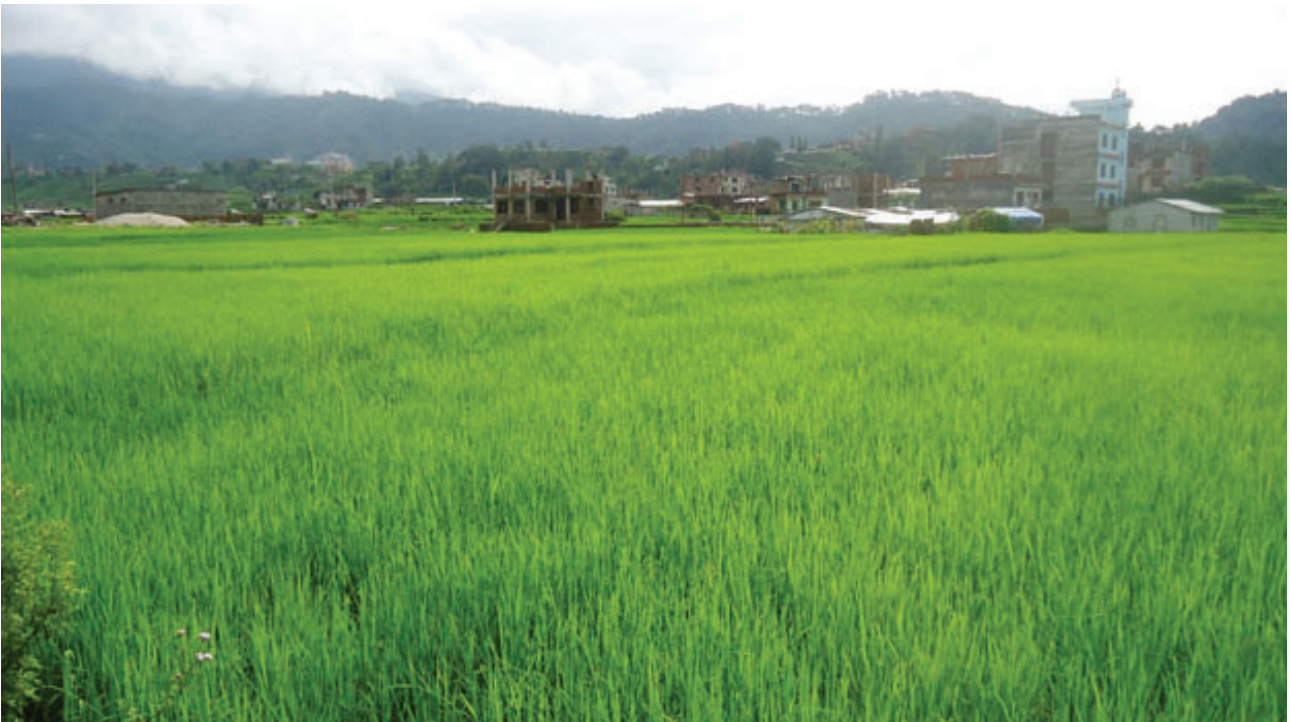
Figure 13: Rice field near Dhobikhola, Chunikhel

In this region gabion embankment, temporary sand bag embankment can be seen. Road is also graveled or only soiled in most of the place. River is not so deep.

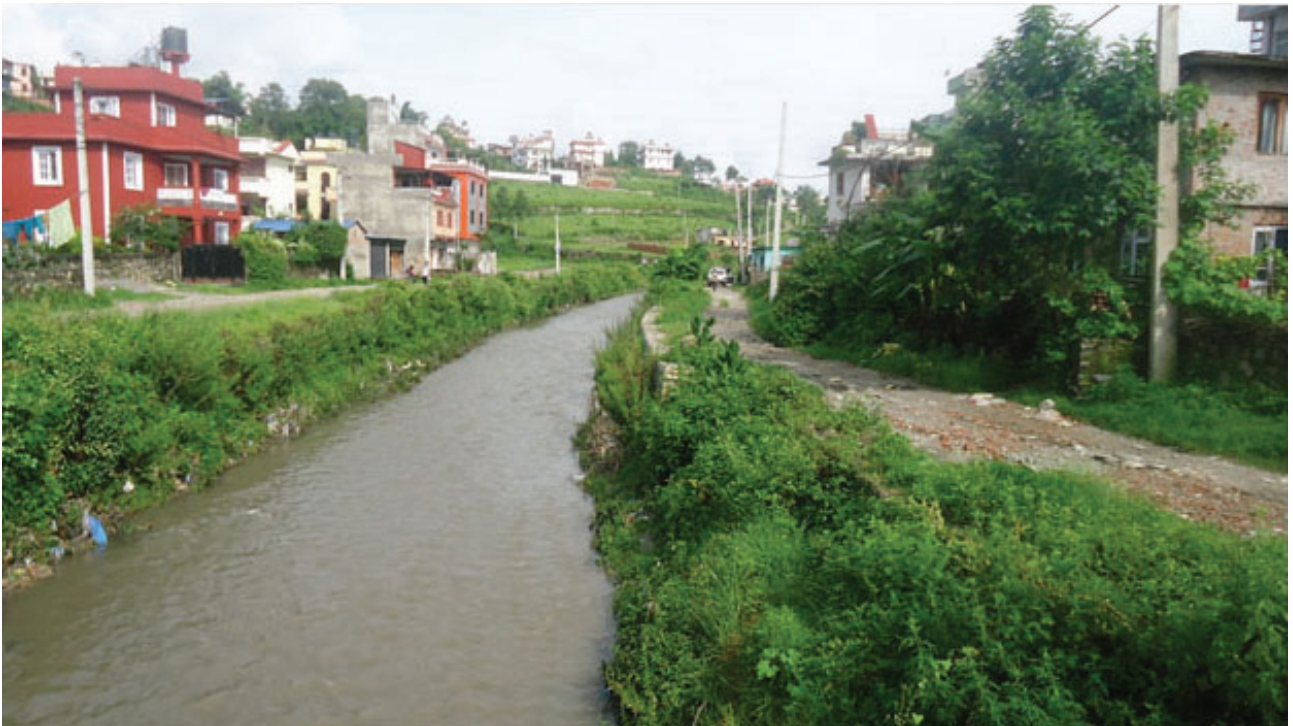
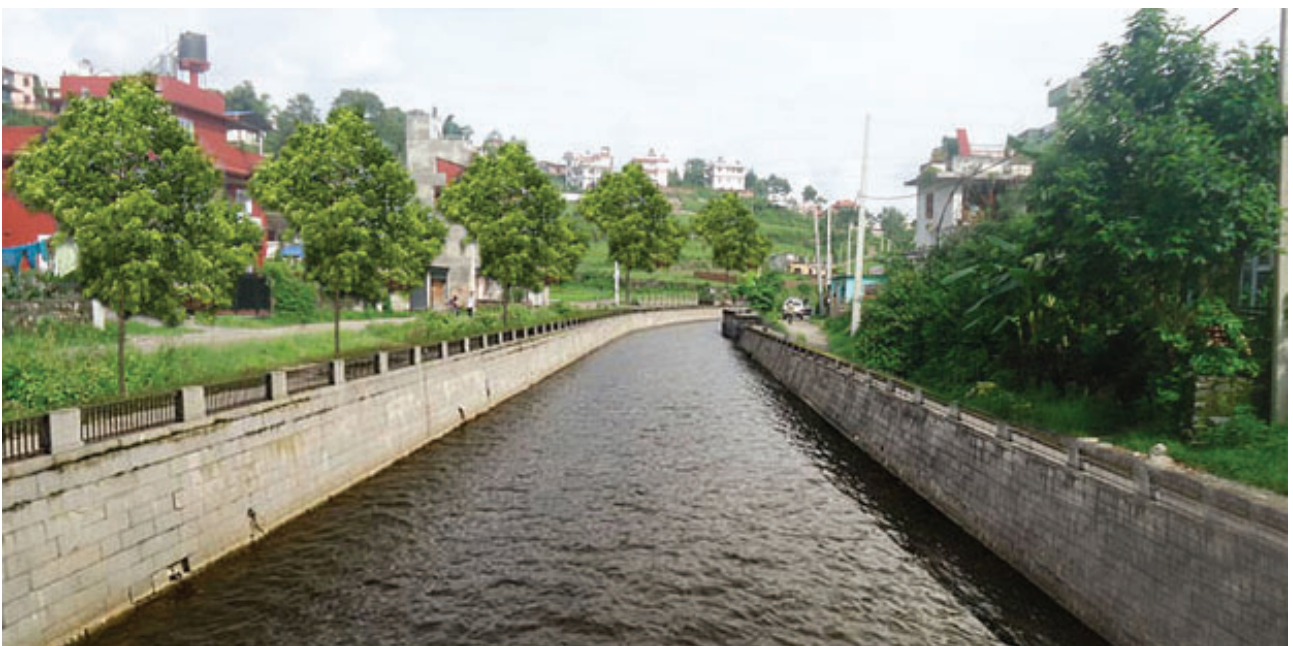
Figure 14: Dhobikhola at upper Kapan, Before

Figure 15: Dhobikhola at upper Kapan, After

As the settlement is not so much in this region (Khadka Bhadrakali to Akase dhara), clear bordering of river territory should be done by embankment. For now small cycle lane and walkways should be made along with single lane motorable road. Sand mining should be strictly checked. Embankment of river should be done after it enters Chunikhel.

Section of river from Dhobidhunga to Khadka-Bhadrakali should be made plastic free. It is an ideal hiking place for avid walkers. So walkable trail should be made. Water diversion at every 200 m should be made so as to facilitate the walkers.

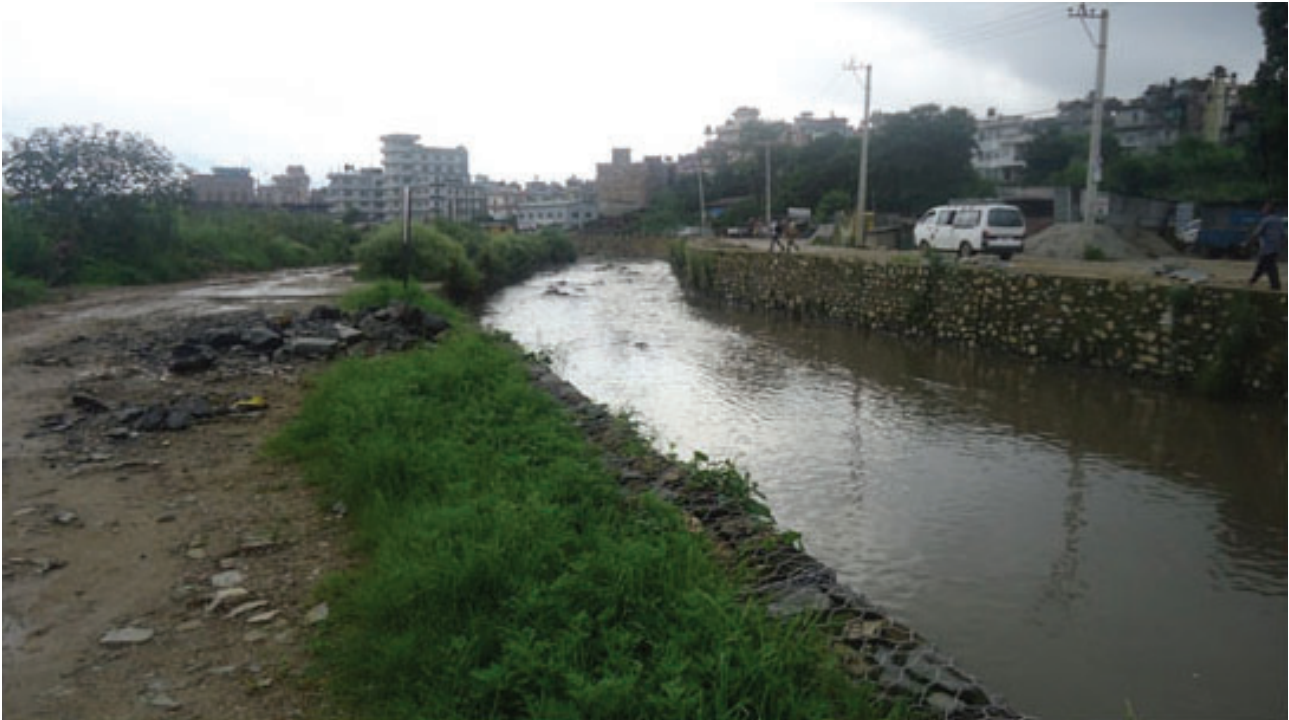
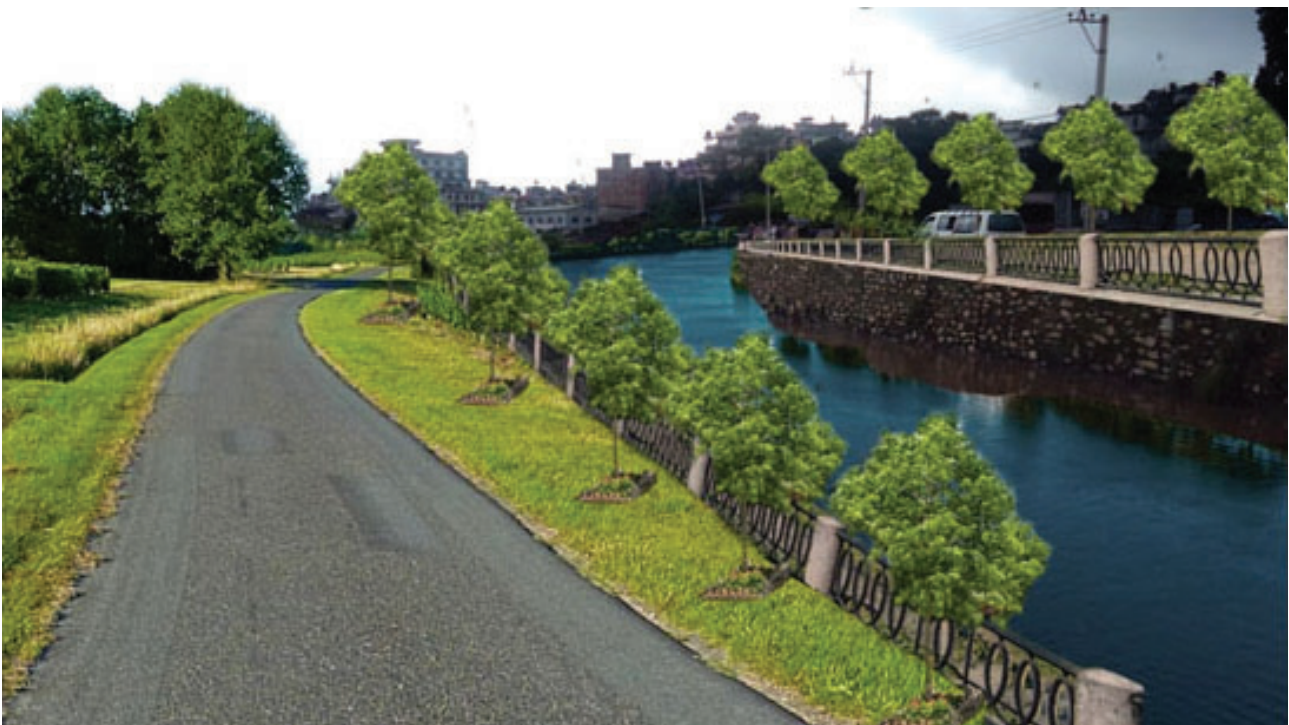
Before

Here I propose embankment of permanent structure. Immediately after that a line of trees can be planted. 10m wide motor able road and separate lane for cycling track can be made. 2m wide pedestrian can also be made in this region. The proposed width of river is 12 m which should be maintained throughout. As the portion of river is encroached, illegal structures should be demolished immediately.

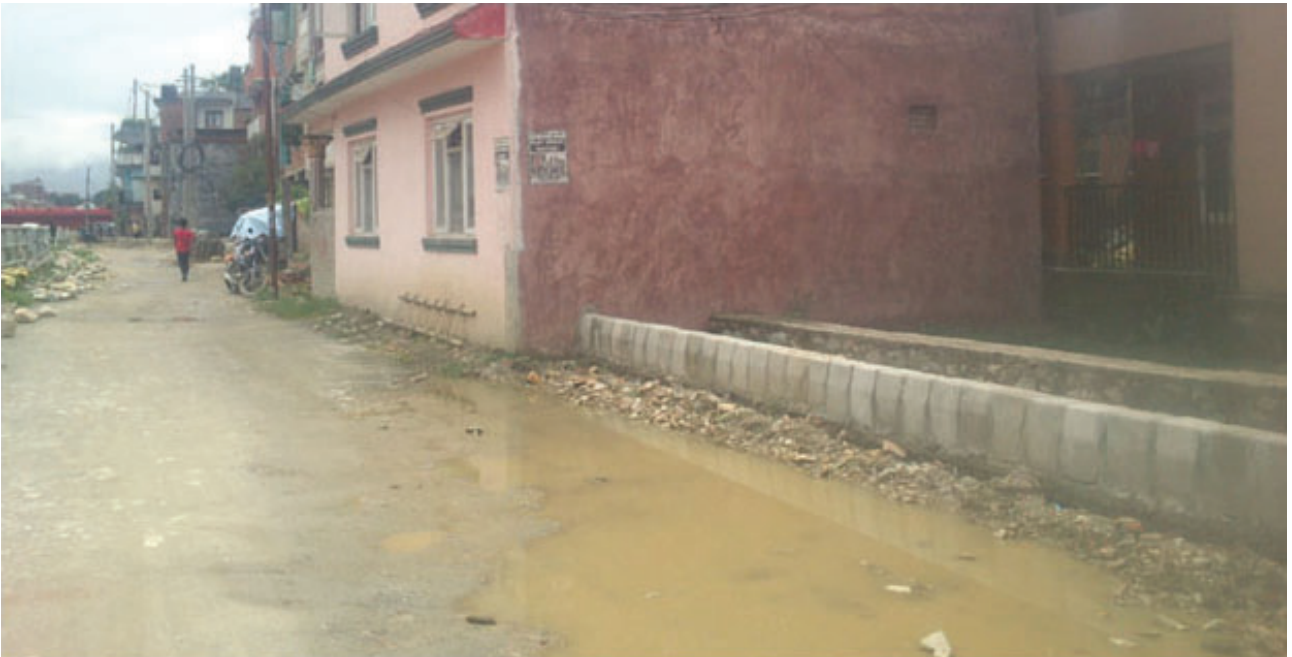
Figure 23: Encroachment by residential buildings

This strip lies within the Ring-road and thus most of riverside have been embanked with permanent embankment. Width of river varies from 10m to upto 20 meters at some places but it's with at most of the places is around 15m. Both side of the river bank is blacktopped or in a construction phase. Riverside construction is very less in strip between Chabahil and Bhatkeko pool. There we can see fields and open spaces. No surprise, we can see many outlets of sewerage pipes here. River water is totally dead and occurrence of river fish and amphibians is negligible. Most of the areas alongside river, after giving space for 10m wide road, has been occupied by residential buildings. Some institutional buildings can also be seen. Waste collection site is there near Bhatkeko pool and under Ratopool. Three major roads crosses the river including Dillibazar- Baneshwor road and the ring road. Some temples can also be seen. Unlike other riverside places here there is no Ghat. Encroachment of river land by local residents and squatters can be seen.

Already construction for 10m wide link-road is under-process by KVDA. At some places due to controversy regarding land-ownership road is even narrower than 10m. I propose 2m wide footpath on river side of road and 1m wide on the opposite. Half meter wide green-belt towards the riverside between footpath and road should also be constructed with trees at every 20m apart. This provides greenery. Since this is heavily populated area, railing should be kept on embankment to safeguard people from falling onto the river. Roadlights should also be fitted alongside the embankment. The space near Kalopool can be used to make a park for social activities. Waste collection site should be moved away from Ratopool and that space should be used to make park. This enhances the aesthetic of river. Instead of mixing sewages into river, trunk sewer line should be constructed alongside the river (under link road) to divert sewages into treatment plants. Underground wiring should be done.

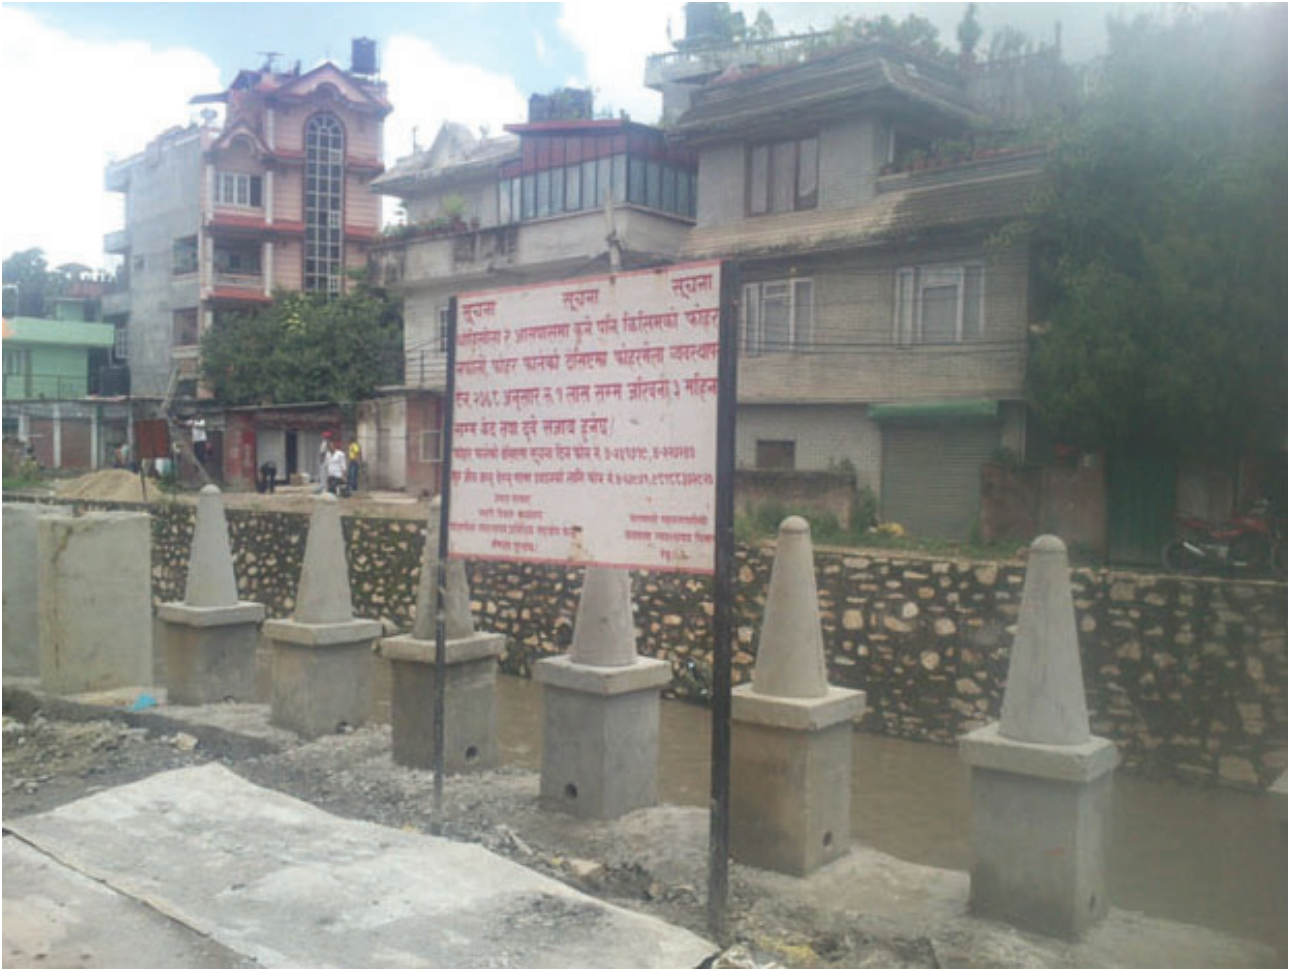
Figure 24: Awareness board and road under construction at the bank of Dhobikhola

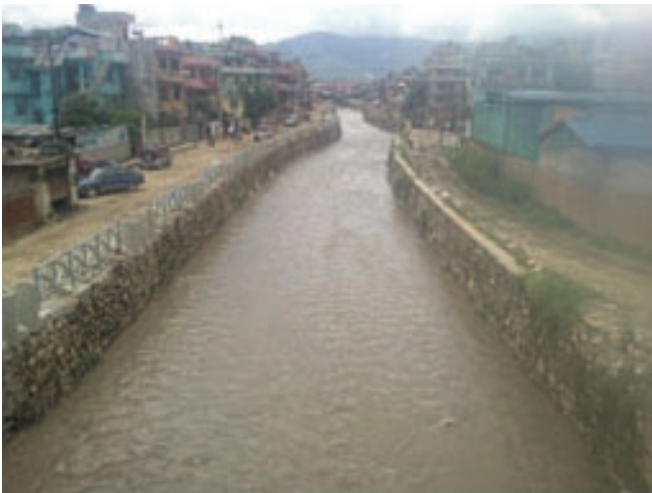
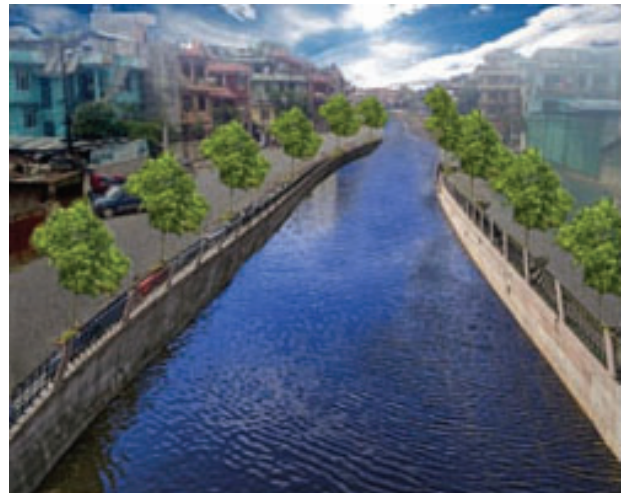
Before

I propose 2m wide footpath on river side of road and 1m wide on the opposite. Half meter wide green-belt towards the riverside between footpath and road should also be constructed with trees at every 20m apart. This provides greenery. Since this is heavily populated area, railing should be kept on embankment to safeguard people from falling onto the river. Roadlights should also be fitted alongside the embankment. The space near dovan can be used to make a park to carry out social activities. Instead of mixing sewages into river, trunk sewer line should be constructed alongside the river (under link road) to divert sewages into treatment plants. Underground wiring should be done.
